| <b>Client:</b> Habika Contracting Project | <b>Office:</b> Tehran | <b>IVR No.:</b> BC-26-7895 |
| <b>Project:</b> - Habika Contracting Project | <b>Other References</b> (If any): - | <b>Report date:</b> 10/10/2026 |

#### 1) Material inspected

#### 2) Scope of inspection

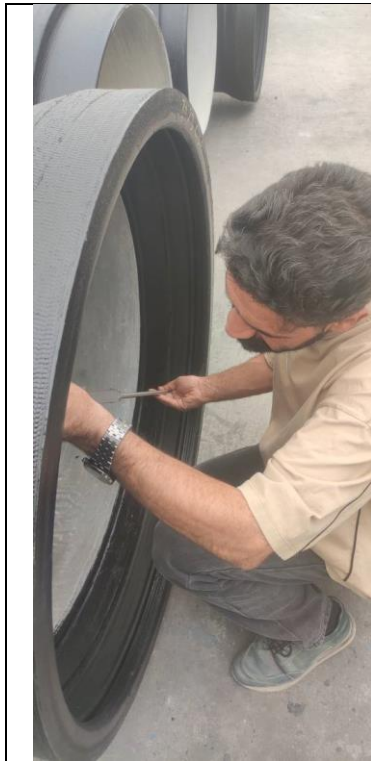
1. DT

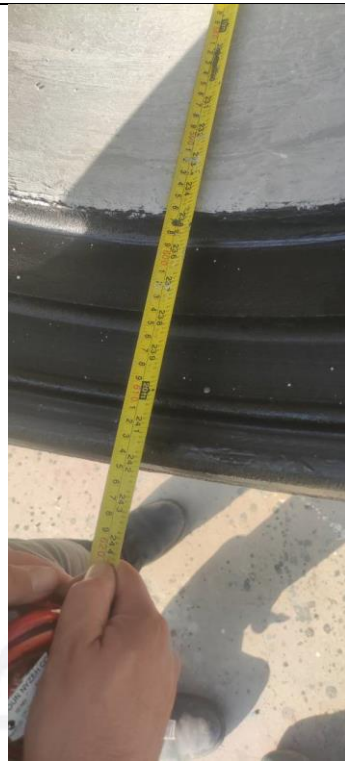
2. DT

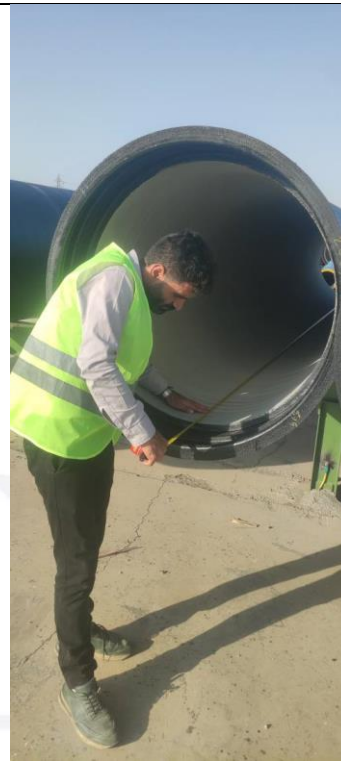
3. DT

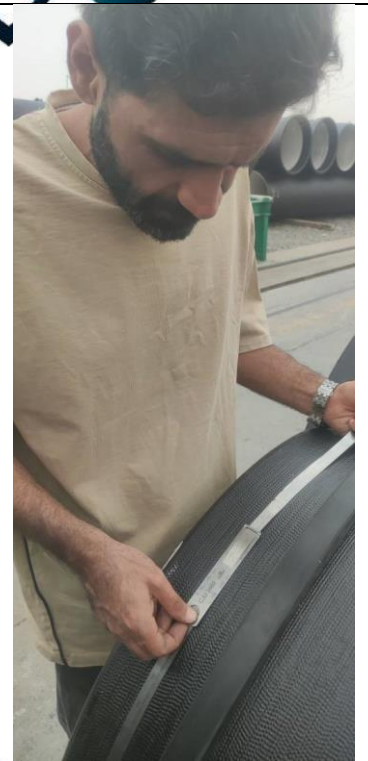
4.DT

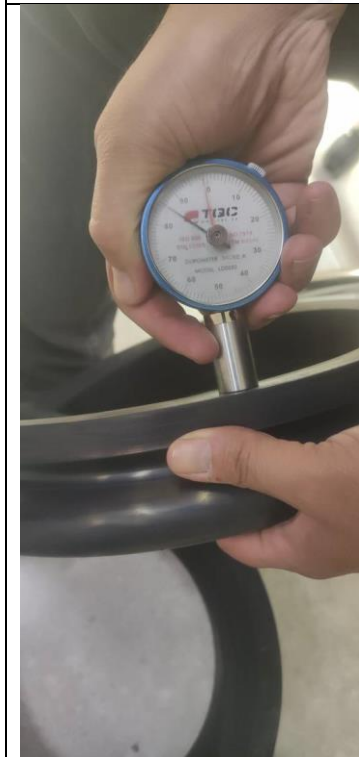
5. hardness

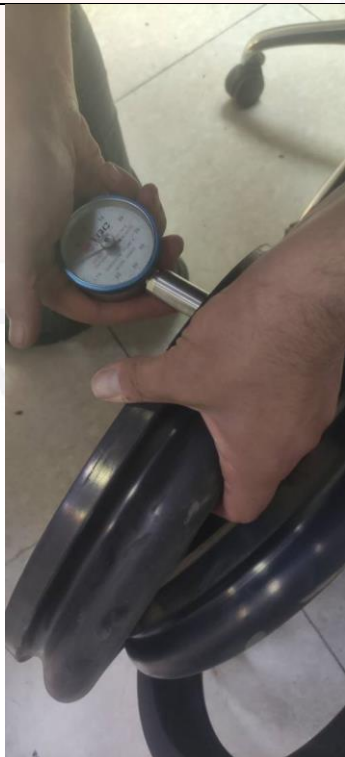
6. hardness

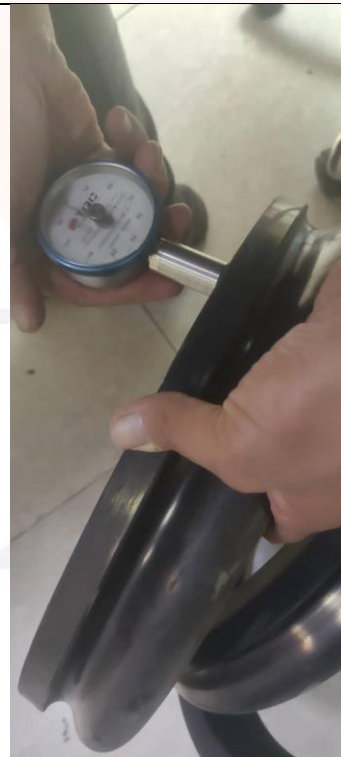
7. hardness

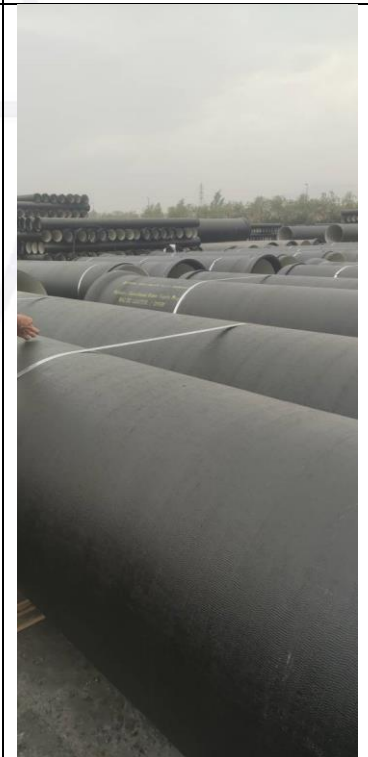
8.VT

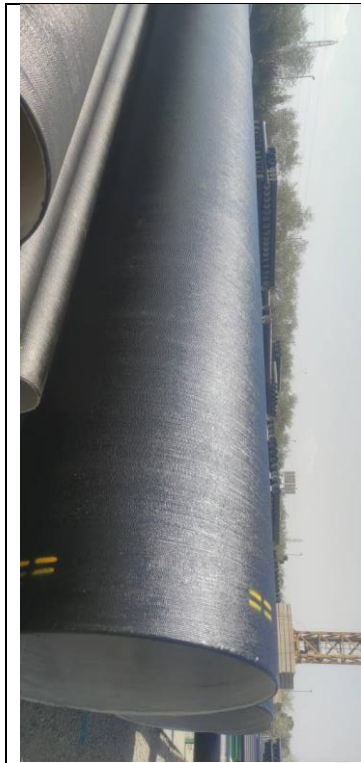
9.VT

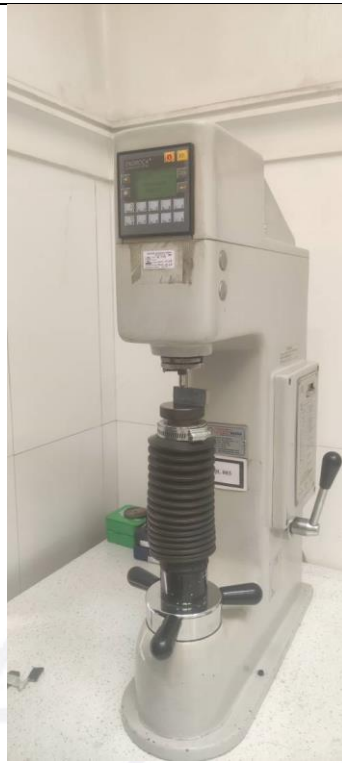
10. hardness

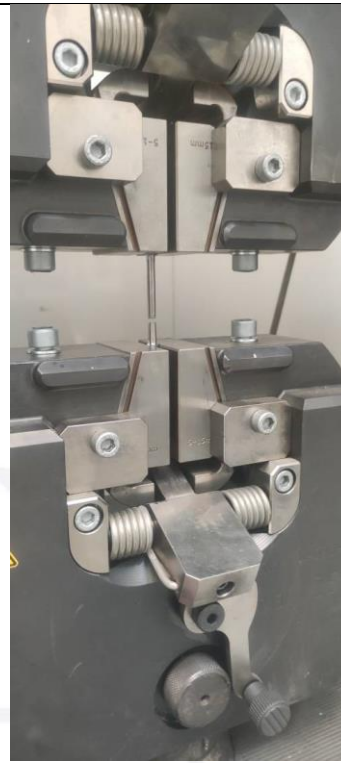
11. tensile

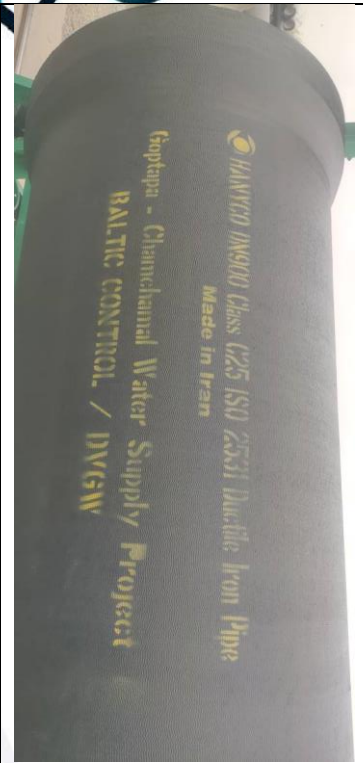
Marking of the pipes was performed in accordance with the customer's request, and no discrepancies were observed.

12.marking

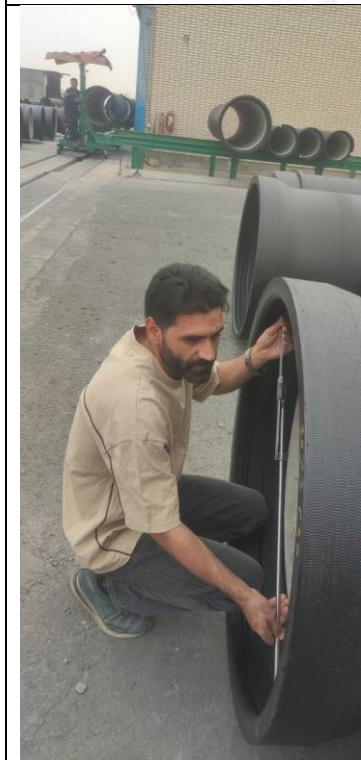
13. DT

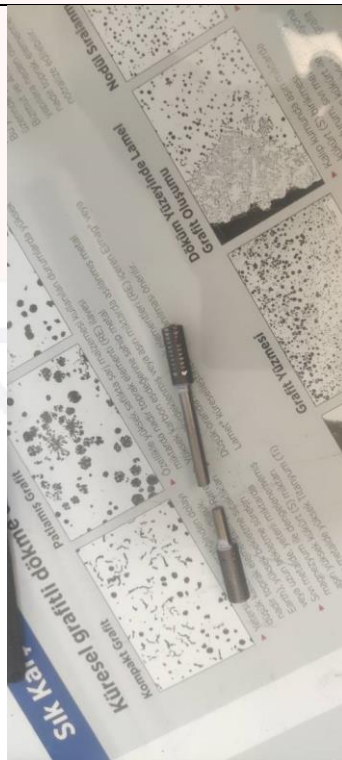
14. tensile

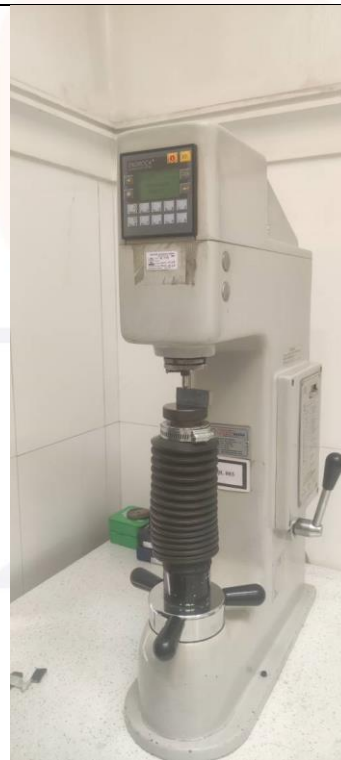
15: hardness

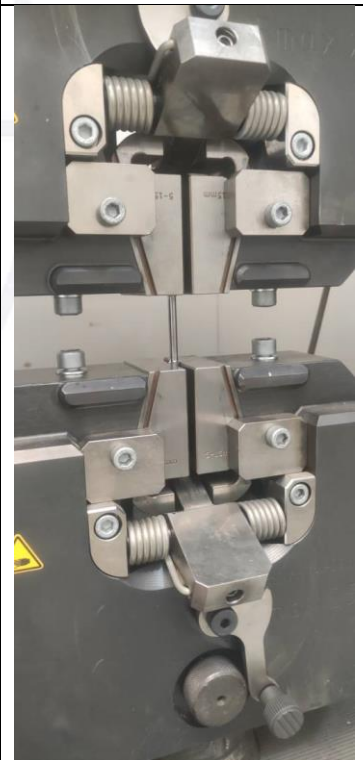
16. tensile

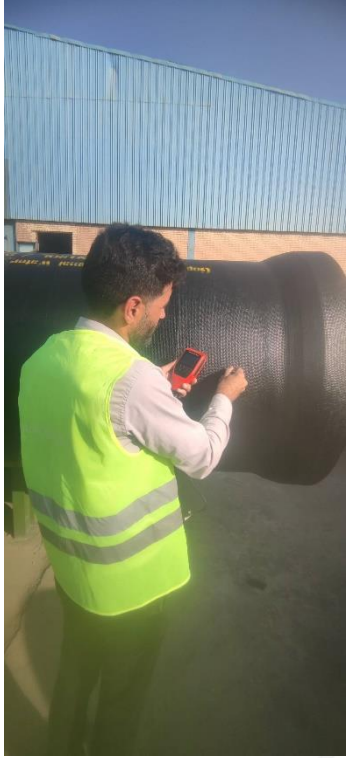
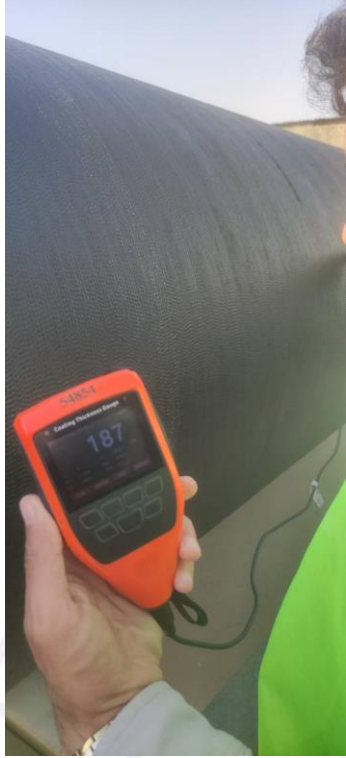
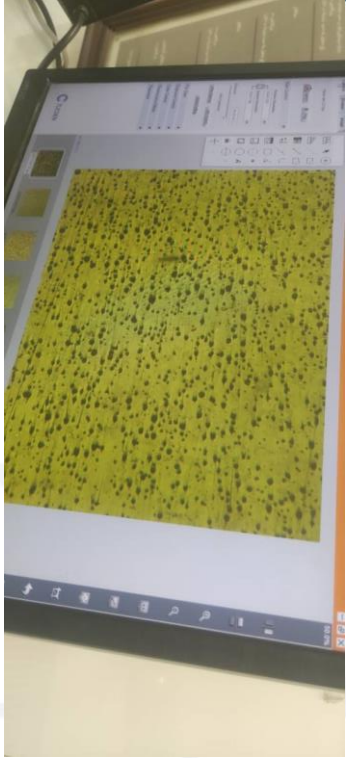
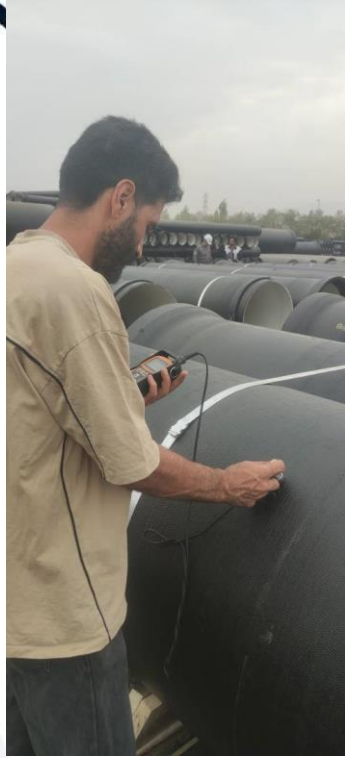
| 17. thickness | 18. thickness | 19. metallography | 20. thickness |
